St. George Parish

Church, Rectory, Garage and Site Facilities Assessment Erie, Pennsylvania

Date: July 2020

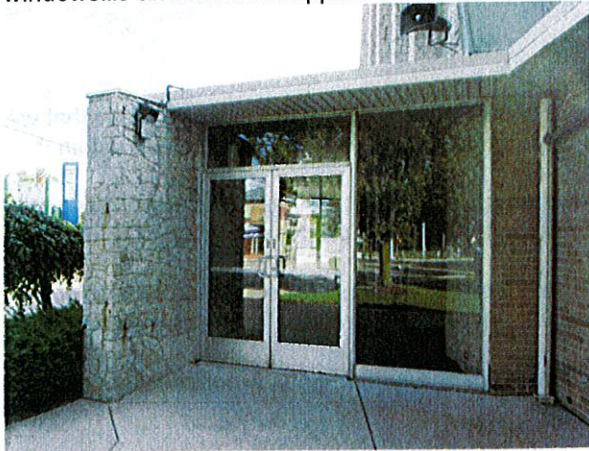
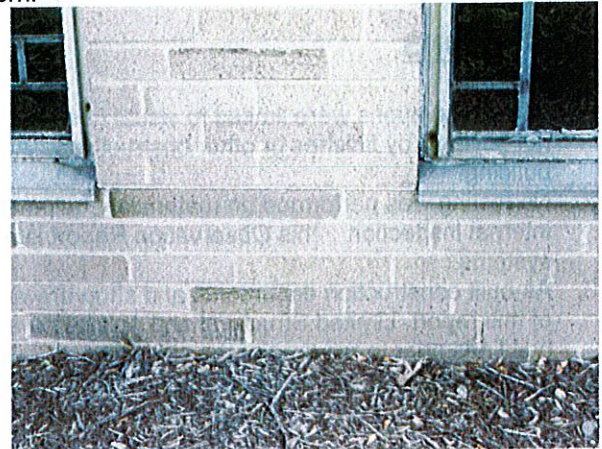
WALLS – The exterior walls of the building are a combination of standard modular brick and stone masonry in fair condition. They are typically constructed as 12" wide multi-wythe brick walls. At the North and West

entrance, exterior radial walls are 16" wide and appear to be constructed out of stone veneer. At all four sides of the church structure, large stained-glass exterior windows run full height between (6) 16" wide stone piers. There were some visible structural cracks due to minor settlement and the need of selective masonry restoration due to mortar deterioration. Also recommend ferrous stain cleaning to remove stains from iron mineral embedded in the original stone. The insulation value of the walls is assumed to be deficient to current codes since the building was built in 1958. There are visible signs of oxidation coming through the stone veneer walls at the building entrances and at the stone veneer piers located at the arched stain glass walls. The oxidation appears to be cosmetic and not a structural concern. There are a number of locations with horizontal cracks in brick mortar joints around the building perimeter. Typically, the joint appears between windowsills and does not appear to be a structural concern.

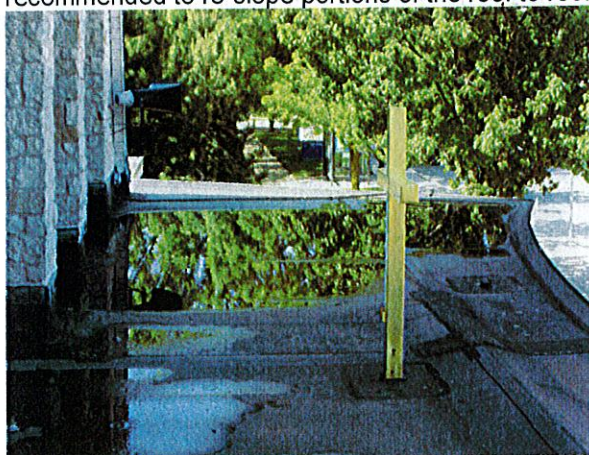
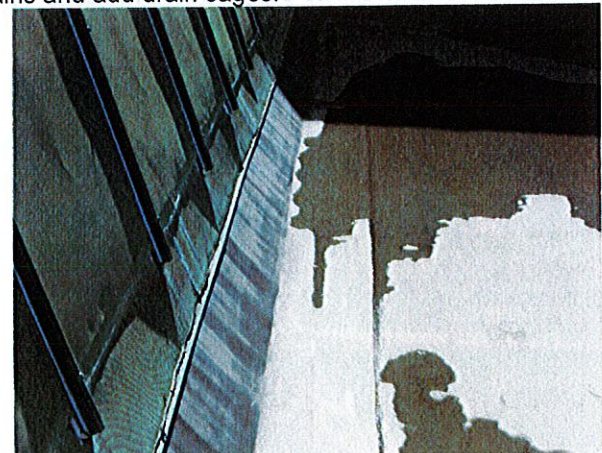
ROOF EPDM – The roof system is an EPDM at the flat roof areas. Based on the age of the building, the roof insulation is not compliant to the current code requirement of an R-value of 30. While walking on the flat roof portions of the church roof, there was visible standing water that does not appear to be sloping to roof-drains. The majority of roof drains do not have a cage to protect from clogging. Standing water and clogged roof-drains can put excess amount of load on the roof structure and increase the likelihood of leaking. It is recommended to re-slope portions of the roof to roof-drains and add drain cages.

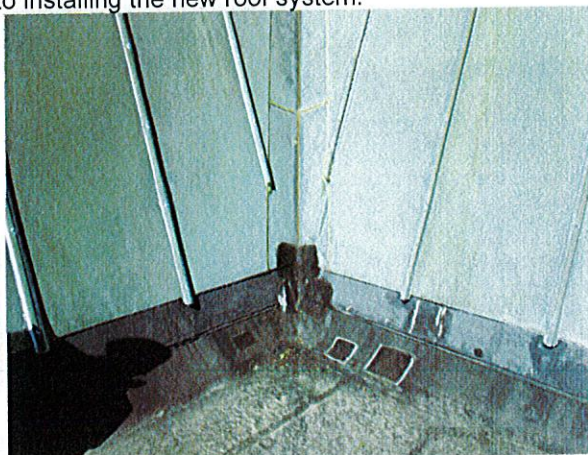
ROOF COPPER – There is also a copper cladding with raised batten seams spaced approximately 2'-0" on center over the arched roof structure. The copper roof is original to the building and is past its useful life cycle and should be replaced. It was observed that someone previously sealed both sides of all copper batten seams with white caulk along the arched portion of roof. The skylight directly above the altar shows signs of leakage as well. It is recommended to remove the copper flashing over the arched roof structure and

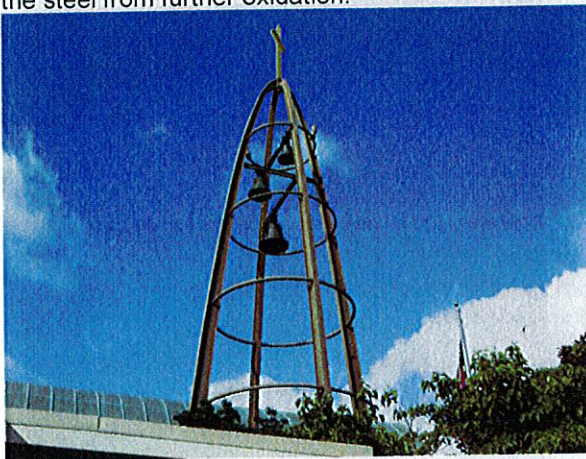
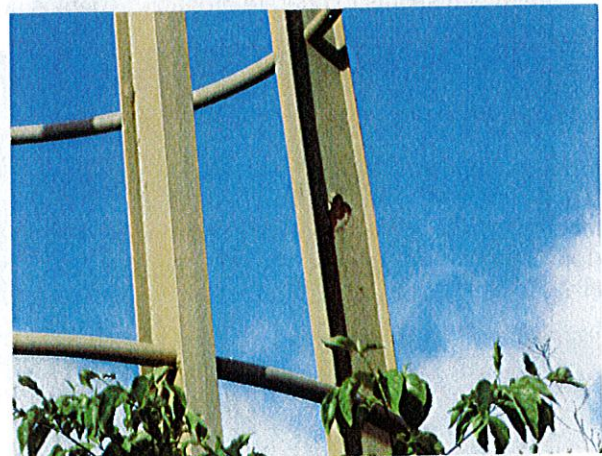
BELL TOWER – There is a bell tower on the west side of the church property which is a steel constructed self-supported tower approximately 65+/- feet tall. Visible peeling paint and rusting was observed at many locations of the steel framed bell tower structure. Oxidation does not appear to have caused section loss of the structural steel. It is recommended to clean the rust off and repaint with an exterior grade paint to protect the steel from further oxidation.

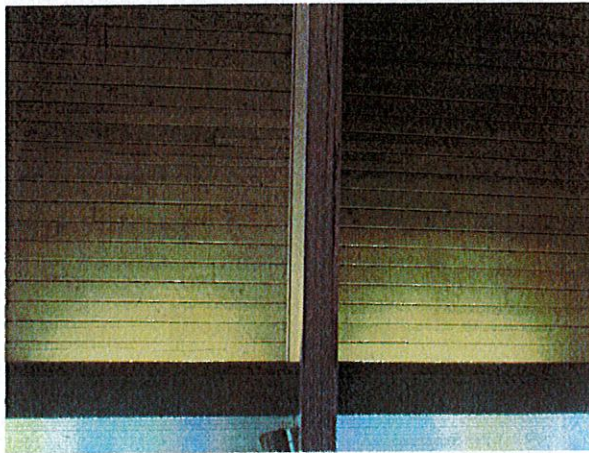
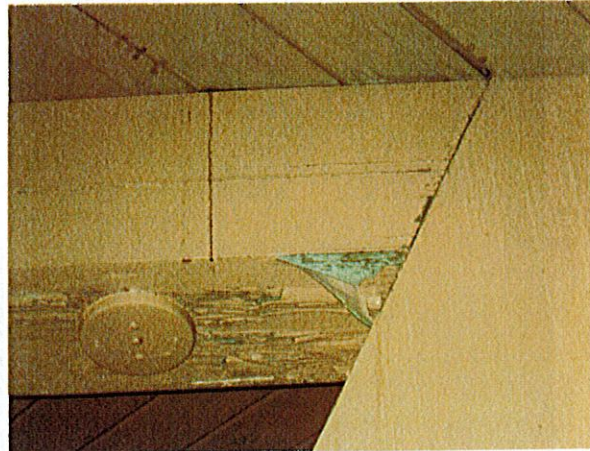
INTERIOR SYSTEMS - The majority of the interior finishes (linoleum sheet flooring, carpet, ceramic tile, suspended acoustical ceiling tile, plaster ceilings, wood decking at arches, gypsum wall board and concrete unit masonry) and casework throughout the building were installed in the original construction and some are evident to have been added over the years through various renovations. These finishes are in good condition. The wood and metal doors appeared to be in fair condition. The Naves are a high-volume open space with large wood laminated arch beam supporting the roof deck. There are a lot of stained-glass windows which let in a lot of natural light. The flooring under the pews is linoleum sheet flooring and is in good condition. The walls are a combination of masonry modular units and painted drywall. The existing church arched roof structure is generally comprised of 3 5/8" wood decking spanning to laminated wood arches spaced approximately 16'-0" on center. Dark water lines are visible on the majority of laminated arches and wood decking that spans between arches. At the time of the site visit, it was noted that the roof has been leaking for years. Paint was visibly chipping on many of the arches, but no structural damage is apparent. Once the roof leaks are fixed, it is recommended to clean/scrape the arches and repaint with a water-resistant interior paint.

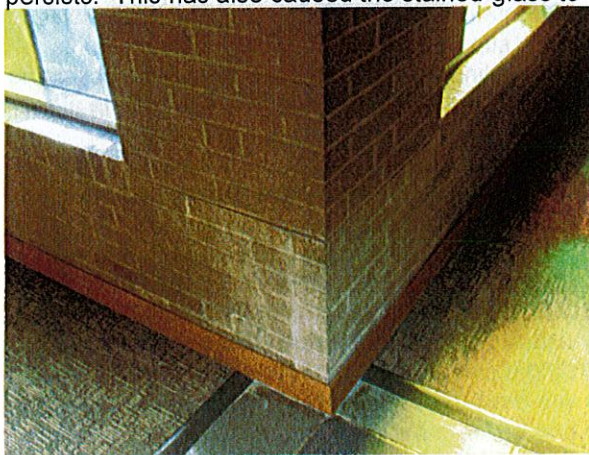
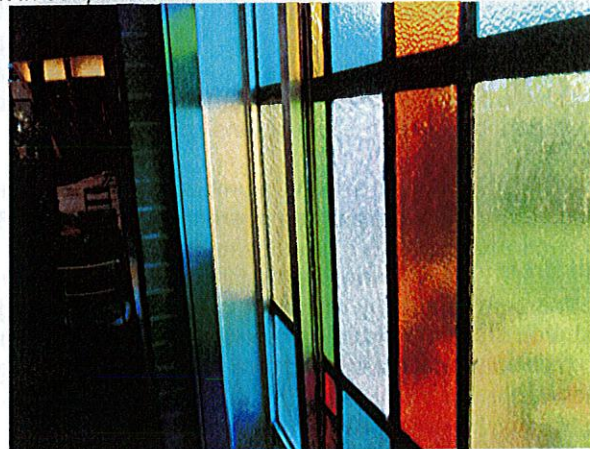
There is one location just northeast of the altar where vertical cracking is visible on the inside face of exterior brick wall. There does not appear to be further signs of foundation settlement in this location. It is recommended to monitor the area for additional cracking and notify a structural engineer if further damage persists. This has also caused the stained-glass to crack in certain locations.

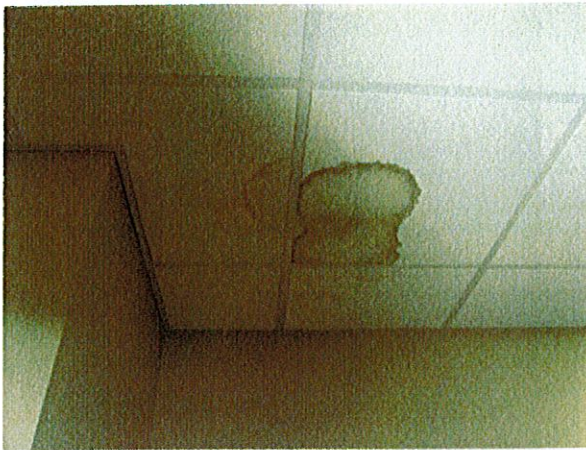
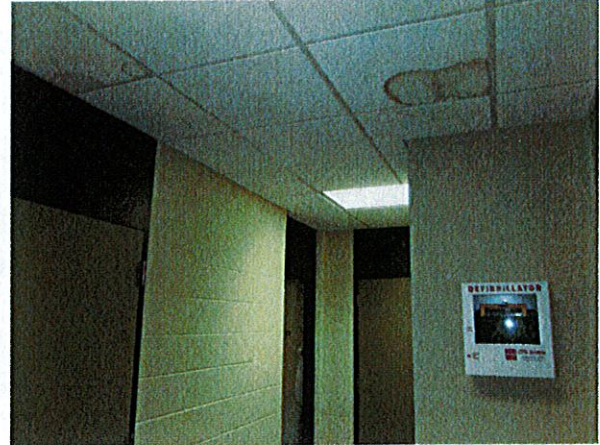
The restrooms are ceramic floor tile with and is in good condition. The restrooms will need to be verified if the fixture counts meet the current occupancy code requirements, as they appear to be deficient. The restrooms will also need to be made larger to account for handicap accessibility space requirements and toilet accessories. In the drop ceiling outside of the restrooms east of the altar, water stains are visible in the ceiling tiles. Further investigation is recommended to find the source of the water damage and fix the issue. It is recommended these ceiling tiles should be replaced.

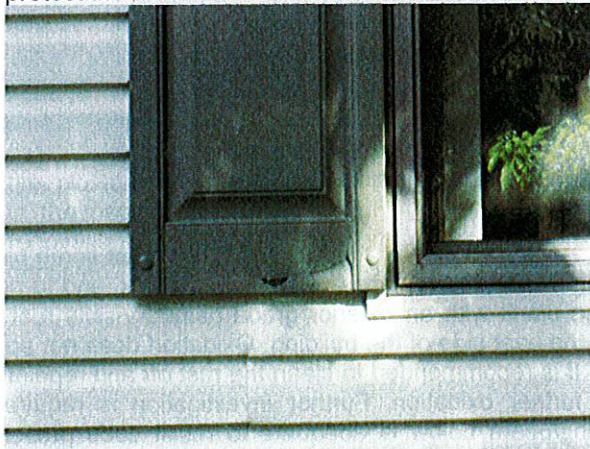
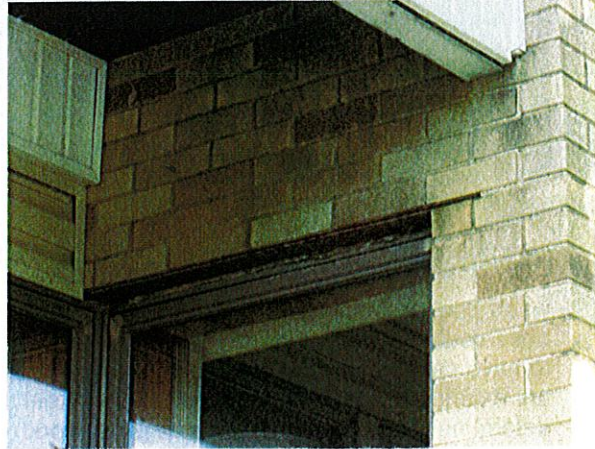
WALLS – The exterior walls of the building are a wood framed construction with vinyl siding at the upper level and there is standard modular brick at the lower level. The insulation value of the walls is assumed to be deficient to current codes since the building was built in 1977. Floor framing consists of plywood sheathing over wood framed 2x joist spanning to wood stud bearing walls. There is a basement below the east half of the rectory facility with masonry perimeter walls. First floor framing was observed in the mechanical room located in the basement and there was no visible damage. No other framing members were visible at the time of the site visit. There is no reason to believe any of the structural framing is inadequate or needs replaced. Some of the vinyl siding shutters are cracked and should be replaced. Visible rust was observed at a loose angle lintel supporting brick veneer at the east side of the building. Oxidation does not appear to have caused section loss of the angle. It is recommended to clean the rust off and repaint with an exterior grade paint to protect the steel from further oxidation.

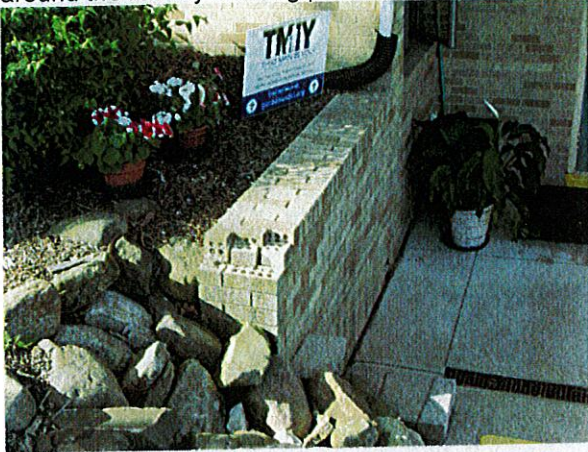
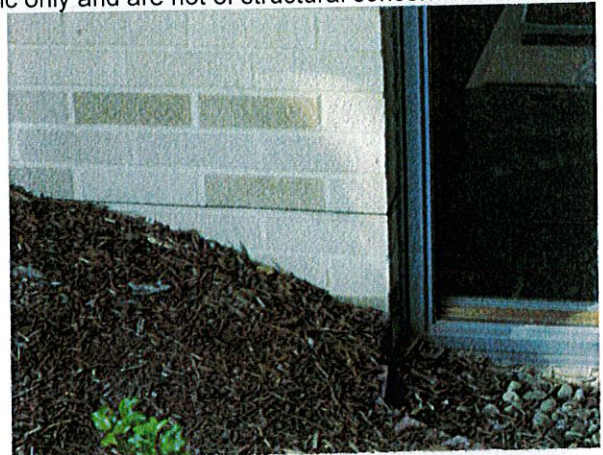
A retaining wall near the north entrance to the rectory building has a slight but visible lean. The wall does not appear to be in jeopardy of failure in the immediate future, but it is recommended to monitor the wall and gauge further movement. Some brick veneer has visible moisture spots below grade of the high side. Further investigation is required to determine if the retaining wall is properly draining or if hydrostatic water pressure is acting on the retaining wall. A possible solution to relieve hydrostatic pressure is to add weep holes just above the low side slab. There are visibly damaged bricks and mortar joints at the retaining wall and brick wainscot around the rectory building perimeter. These are cosmetic only and are not of structural concern.

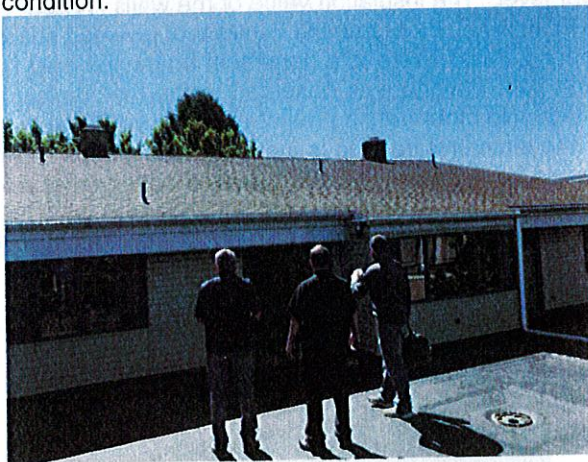
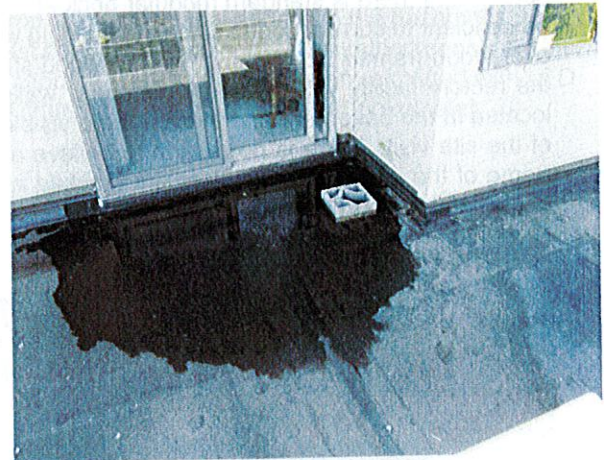
ROOF – The existing rectory roof system appears to be a typical residential style shingled roof on plywood sheathing over wood framed 2x joist/trusses spanning to wood stud bearing walls. The roof system is an EPDM at the flat roof areas. Based on the age of the building, the roof insulation is not compliant to the current code requirement of an R-value of 30. While walking on the flat roof portions there appears to be some ponding water. Overall, both the asphalt shingles sloped roofs and flat EPDM appear to be in fair condition.

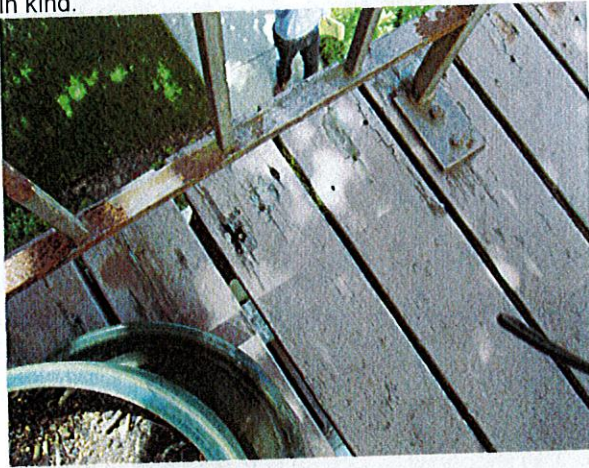
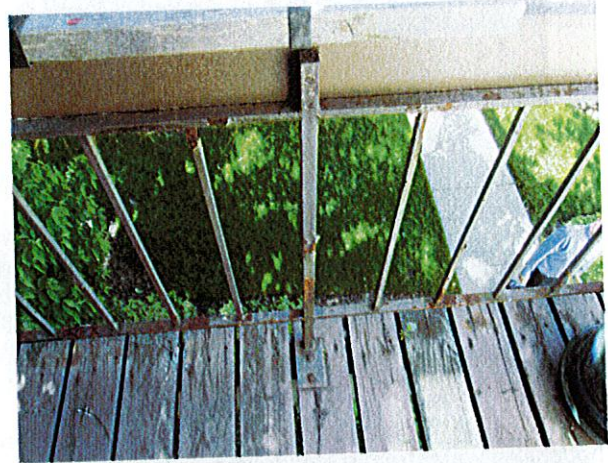
There are also four exterior balconies from the second-floor bedrooms. Visible sun and moisture damage/rot was observed at the 2nd floor balcony wood decking at the east side of the building. The top of some planks show significant rot and exposed fasteners. It is recommended to replace any damaged plank, and to power wash peeling paint, seal and repaint the salvageable plank with an exterior grade paint. Visible rust was observed on the 2nd floor balcony handrail system at the east side of the building. Oxidation does not appear to have caused section loss of the handrail structure. It is recommended to clean the rust off and repaint with an exterior grade paint to protect the steel from further oxidation. Further investigation is required to determine if the handrail anchorage to wood decking/beam below is adequate to resist code prescribed

handrail loading. If wood decking under handrail posts have section loss/rot, the 2x member shall be replaced in kind.

(2) Wood deck and railing replacement		Very Bad	9,000	Wood decks are unsafe. Rubber roof area has ponding water.
Repair Rubber roof and install pavers		Poor	5,000	
<u>Water Damage</u>				
Drywall, tape and paint living room and dining room ceilings		Poor	2,100	Water damage in the living room, dining room and above the water fountain.
Replace ceiling tile above water fountain.		Poor	25	
<u>Masonry</u>				
Repoint East bsmt stairwell and repair front retaining wall		Bad	6,900	Retaining wall continues to move due to poor drainage.
<u>HVAC</u>				
Upgrade existing boiler to a high efficiency model		Fair	20,000	HVAC systems are aging and inefficient.
Upgrade existing domestic water heater		Poor	5,000	
Replace circulating pumps		Poor	12,000	
Provide ventilation for the basement meeting room		Poor	10,000	
Rectory Sub Total			\$ 112,525.00

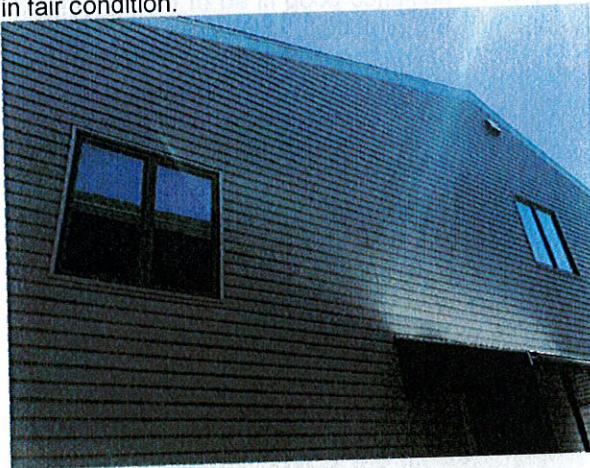
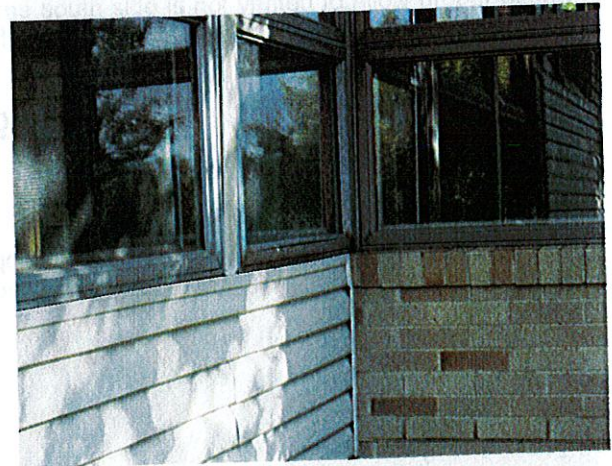
WINDOWS and DOORS – The exterior windows appear to be original to the building. It is recommended they be replaced to improve the thermal performance of the building and minimize drafting. Some of the wood widow sills show signs of deterioration. The upper level balcony sliding glass doors are original to the building and should be replaced if the widows do to improve thermal performance and minimize drafting. There was some visible water infiltration at the southeast doors. The exterior single man doors appear to be in fair condition.

Description	Condition Indicator	Condition	Estimate	Comments
<u>Windows & Doors</u>				
Window, sliding door and trim material		Bad	26,500	Windows and sliding doors are original and are in need of replacement
Window, sliding door and trim labor		Bad	16,000	
<u>Patios</u>

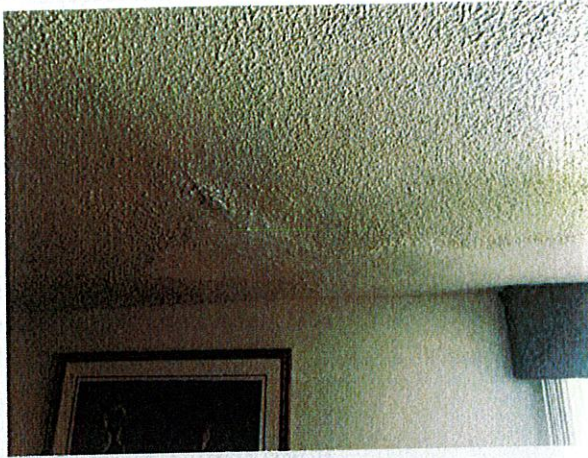
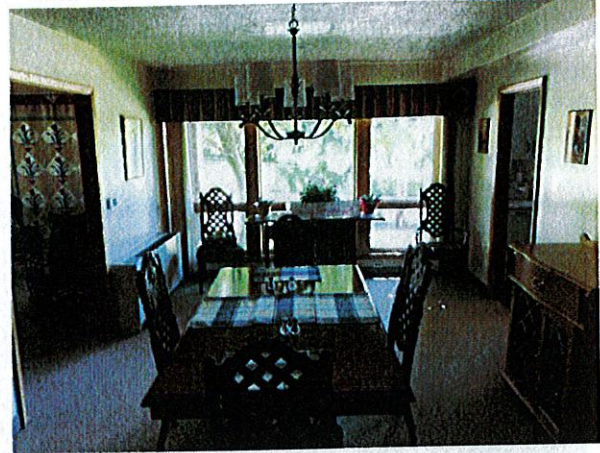
INTERIOR SYSTEMS - The majority of the interior finishes (carpet, ceramic tile, suspended acoustical ceiling tile, plaster ceilings, wood decking, gypsum wall board) and casework throughout the building were installed in the original construction and some are evident to have been added over the years through various renovations. These finishes are in good condition. The wood and metal doors appeared to be in fair condition. There appeared to be water damage at the ceiling of the living room. It should be repaired and painted.

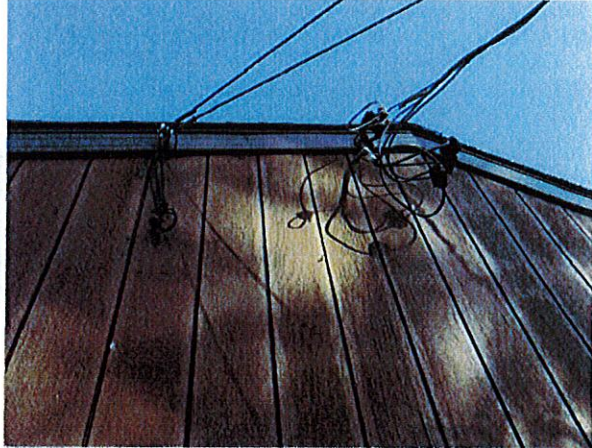
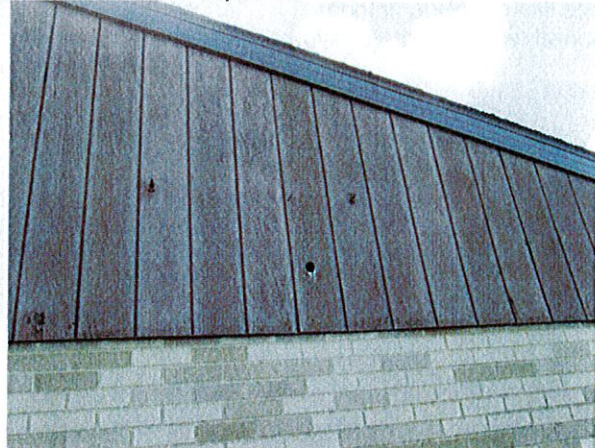
WALLS – The exterior walls of the building are a concrete masonry unit load bearing construction with brick veneer which appears to be in good shape. It has vertical wood planking at the gable ends at the top of the bottom chord of the trusses. The walls have no insulation installed. There are some holes and deteriorated wood and it is recommended the holes be filled and deteriorated wood be replaced.

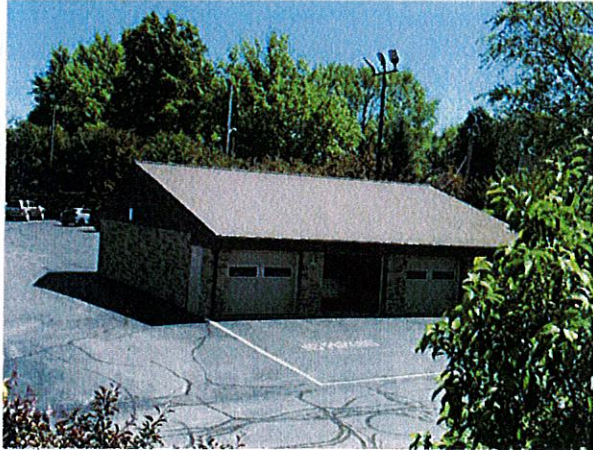
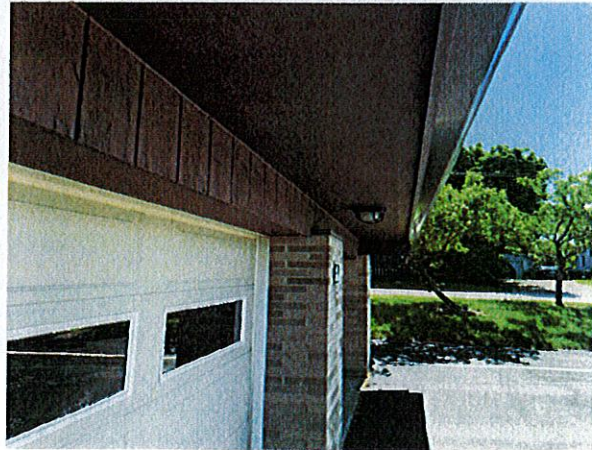
ROOF – The existing garage roof system appears to be a typical residential style shingled roof over plywood sheathing spanning over wood framed trusses and 2x joist at 2'-0" on center. Wood trusses/joists span to exterior masonry bearing walls with an interior masonry bearing wall running the length of the garage. The shingles appear to be in good condition. The soffit on the south side is not vented to allow proper airflow to prevent the shingles from baking in the sun and reducing their useful lifespan. It is recommended to install vented soffit.

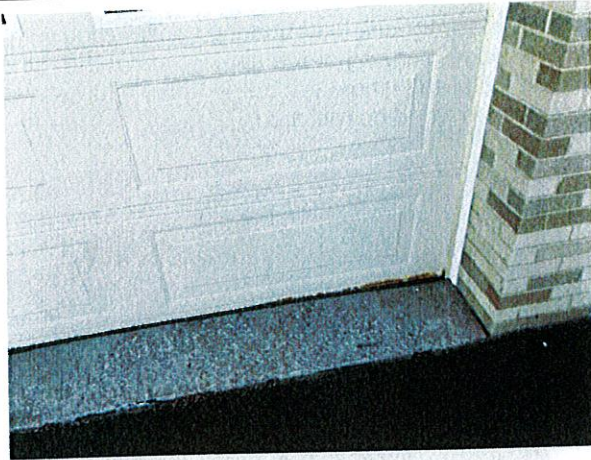
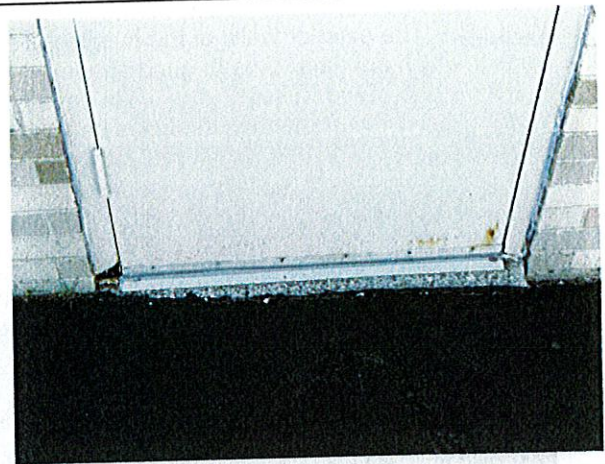
DOORS – The exterior man doors and garage doors show some visible rusting on the bottom. It is recommended they be sanded and painted with an exterior grade paint.

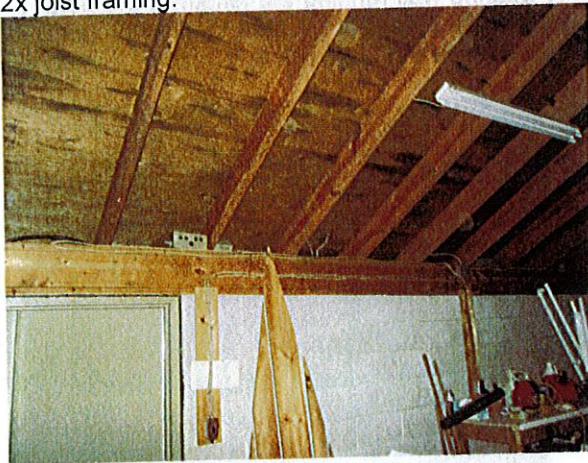
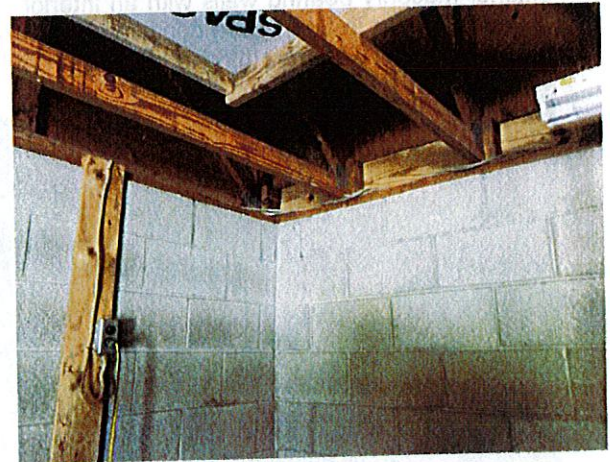
INTERIOR SYSTEMS – The interior is exposed and unfinished concrete masonry units, wood trusses and a concrete floor. A sealer could be applied to the concrete floor to minimize damage from winter salt. The roof trusses do not appear to have any positive attachment to the 2x plate running along the top of masonry walls. It is recommended that Simpson H2.5A anchor be added to each end of wood trusses and at the low end of 2x joist framing.

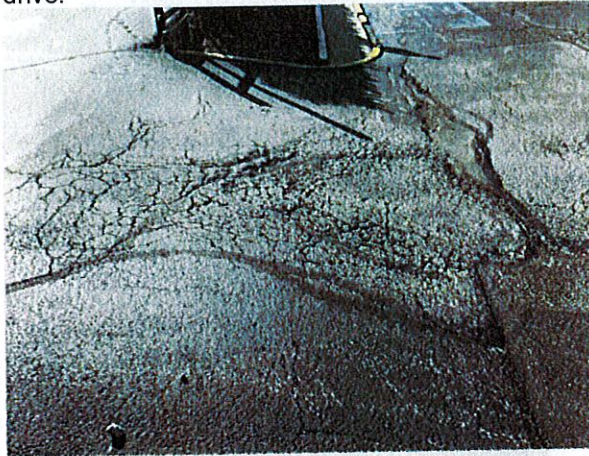
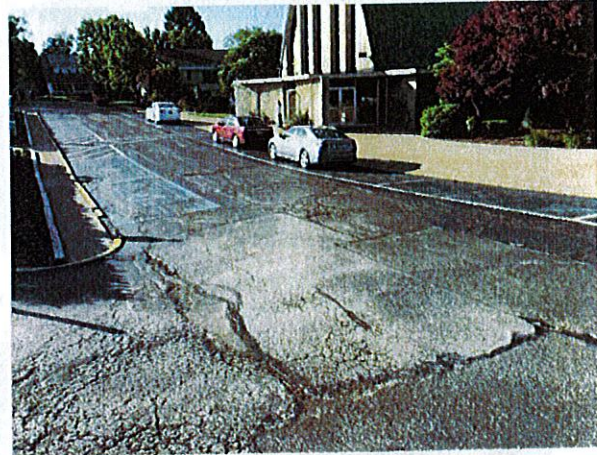
ASPHALT PAVING – The exterior paving at the main entrance road has numerous visible cracks and appears to be damaged. The north parking lot has areas of damaged asphalt. It is recommended to mill and overlay the entire paved area. Or as part of a phasing approach, only mill and overlay the main entrance drive.

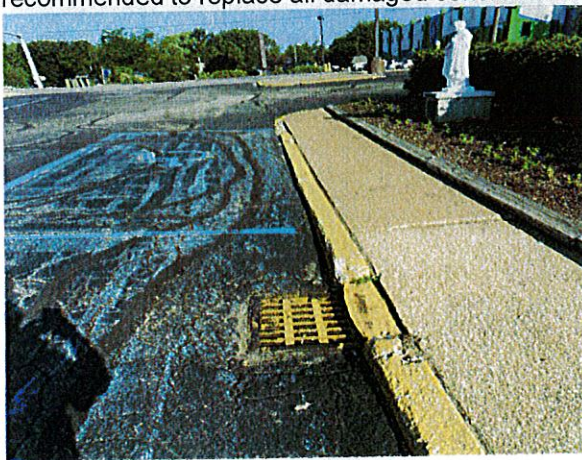
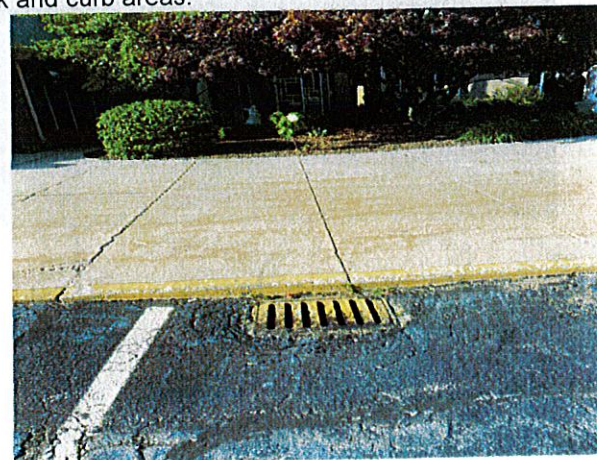
CONCRETE SIDEWALKS AND CURBS – The existing sidewalks and curbs have some good areas and other areas are damaged. Cracks and heaving in the concrete can be tripping safety hazards. It is recommended to replace all damaged concrete sidewalk and curb areas.

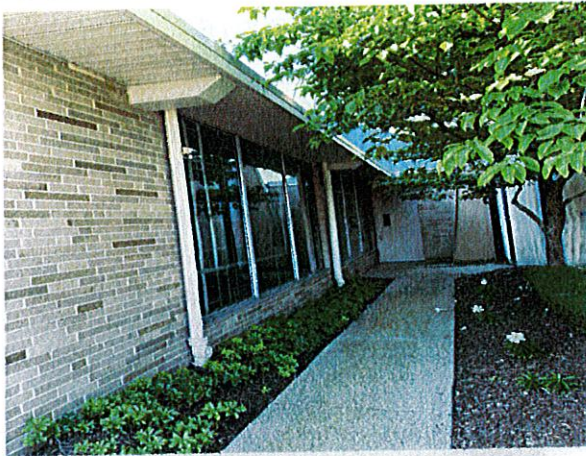
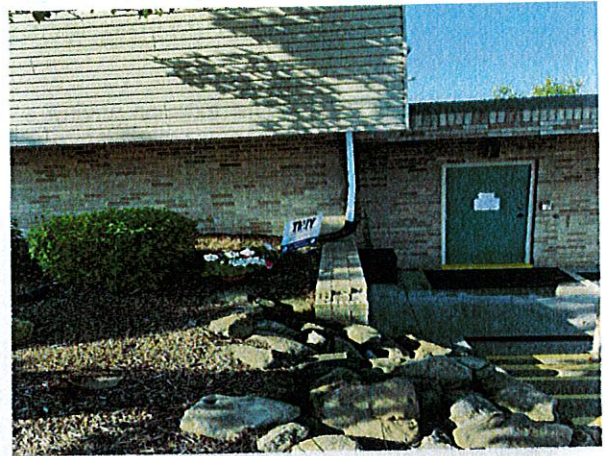
UNDERGROUND INFRASTRUCTURE AND PIPING – The existing storm water management systems observed appeared to have no visible issues and seemed to be functioning properly and are operational. The Church had most downspouts tied to the underground system but had a few downspouts that just daylighted on the ground. The Rectory had all downspout daylighted at grade with no tie into the underground storm water system. The Garage had all downspouts tied into the underground storm system. It is advisable to have the storm water conveyance system televised for inspection, locating, and cleaning as needed. This will then locate all pipes for down spouts, all pipes from catch basins, and main line pipes. Then hydro jet pipes and vac out debris as needed.

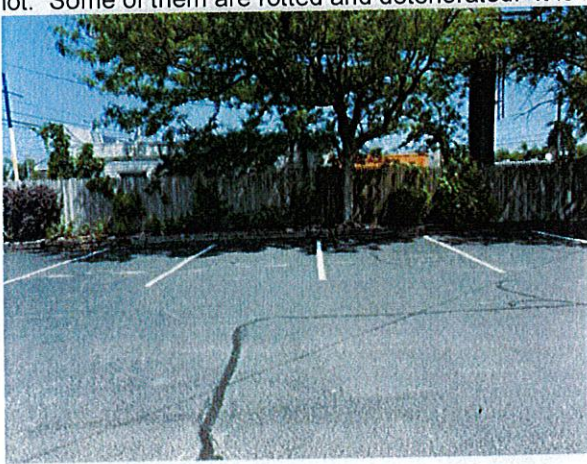
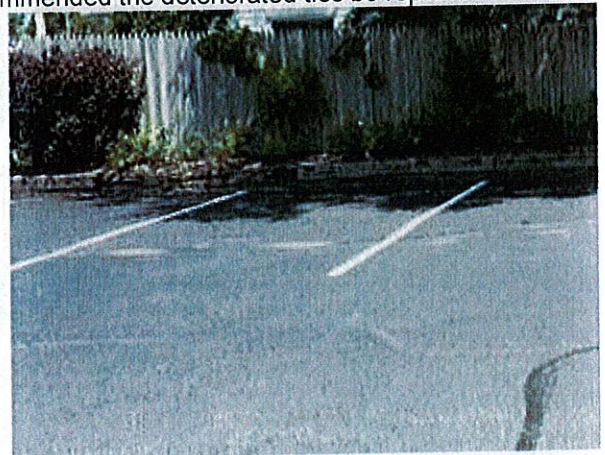
LANDSCAPE RAILROAD TIES – There are landscape railroad ties installed at the north end of the parking lot. Some of them are rotted and deteriorated. It is recommended the deteriorated ties be replaced.
