St. George Parish

Church, Rectory, Garage and Site Facilities Assessment Erie, Pennsylvania

Date: July 2020

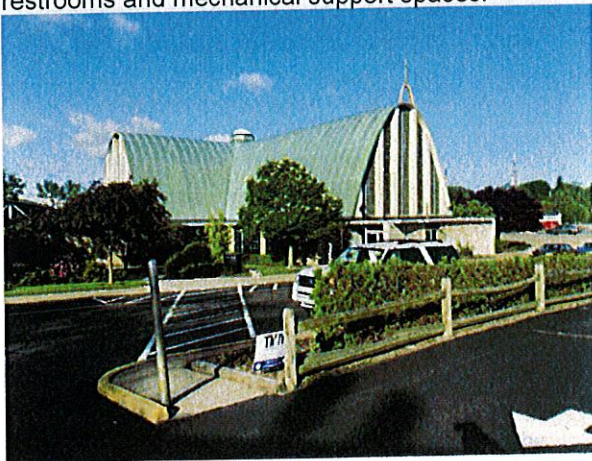
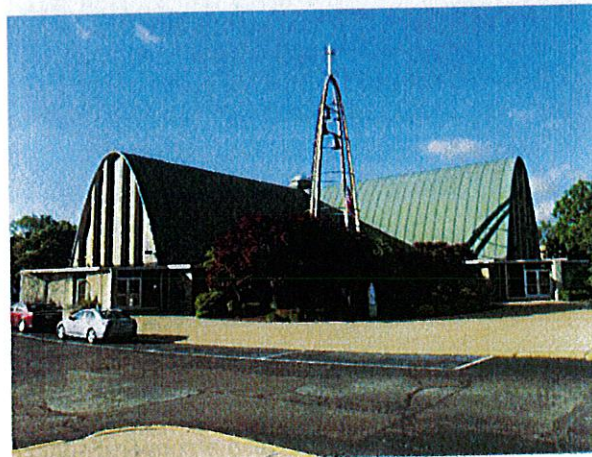
The church and is a one-story structure that is approximately 15,000 square feet in size. The building was originally constructed in 1958. The building program contains the Narthex, Nave, Alter, Mother's Room, Sacristy, restrooms and mechanical support spaces.

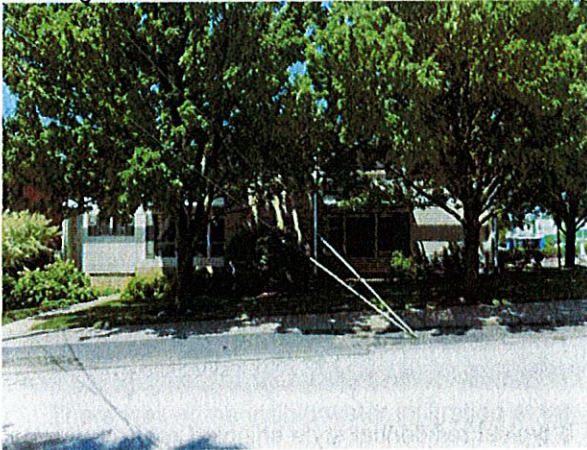
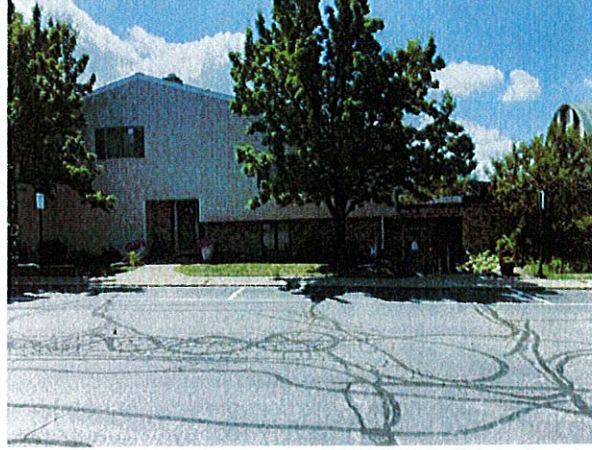
The rectory is a two-story structure that is approximately 5,700 square feet residence with a 1,000 square feet single story portion and a 1,250 square feet basement. The building was originally constructed in 1977. The building program contains a large meeting room, a reception area with open offices, private offices, a lower level meeting room and the east side contains a two-story living quarters and associated mechanical support spaces.

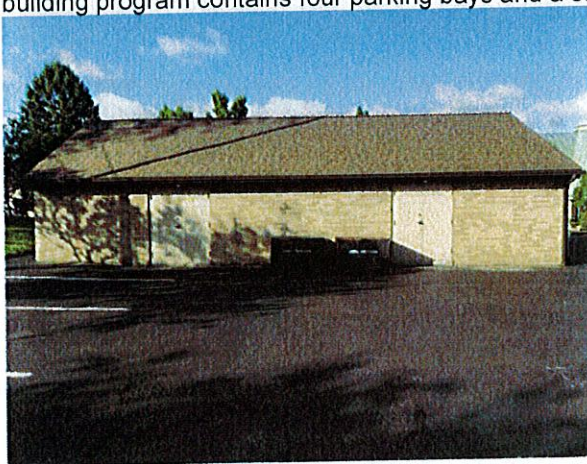
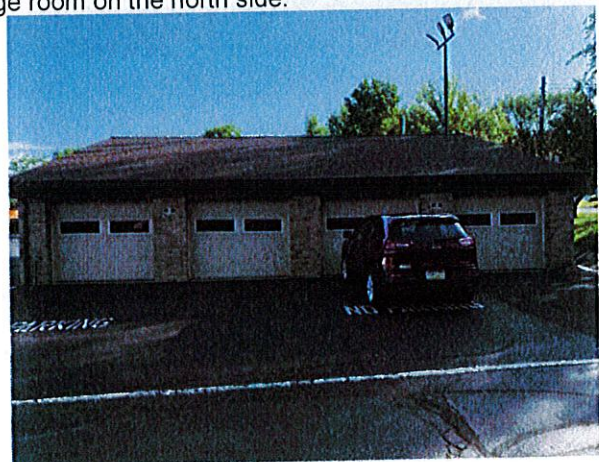
The parking garage is a one-story structure that is approximately 1,800 square feet. The date of construction was unknown at the time of the site visit and no existing drawings were made available prior to the site visit. The building program contains four parking bays and a storage room on the north side.

WALLS – The exterior walls of the building are a concrete masonry unit load bearing construction with brick veneer which appears to be in good shape. It has vertical wood planking at the gable ends at the top of the bottom chord of the trusses. The walls have no insulation installed. There are some holes and deteriorated wood and it is recommended the holes be filled and deteriorated wood be replaced.
